## On/Off Fan Drive Diagnostic and Warranty Guide

Revision 20120402A

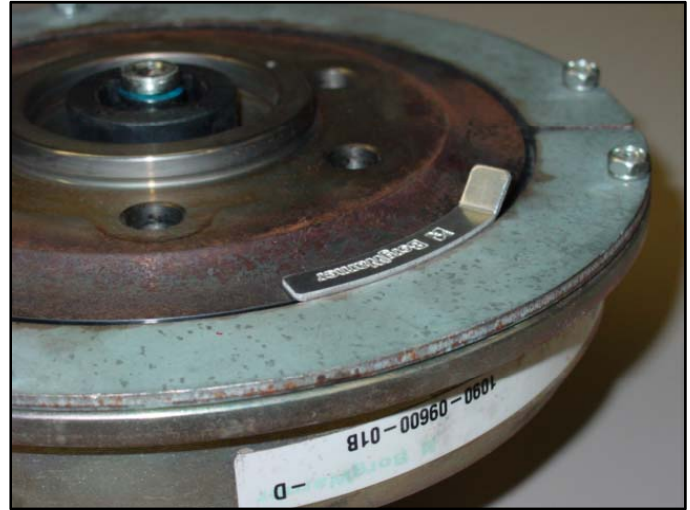
Liner Replacement Necessary

If the Service Alert Tool sits below the surface of the retainer plate (as shown in the image on the left) then the liner has life remaining. If the Service Alert Tool sits above the surface of the retainer plate (as shown in the image on the right) then the liner should be replaced as soon as possible. See Pg 18 to determine whether a control system issue is responsible for rapid liner wear.

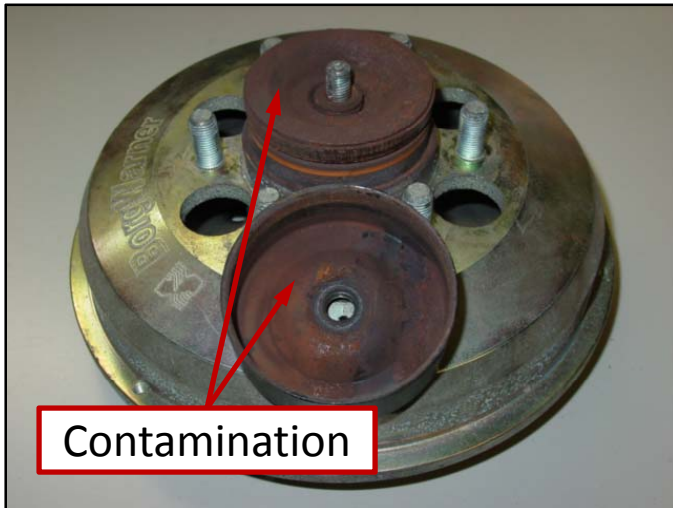
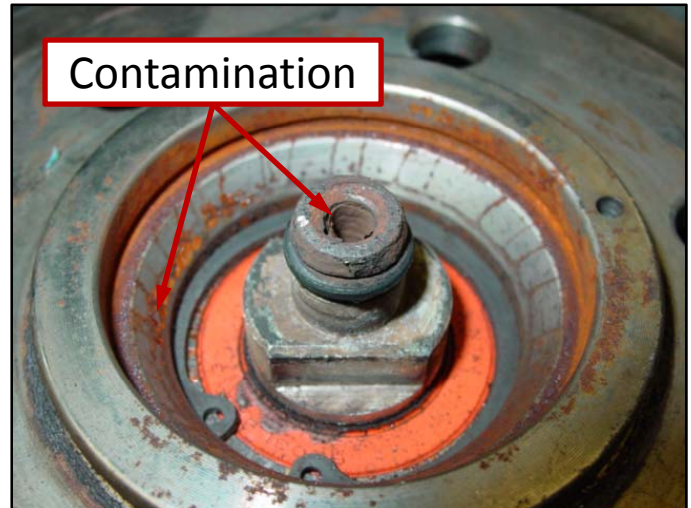
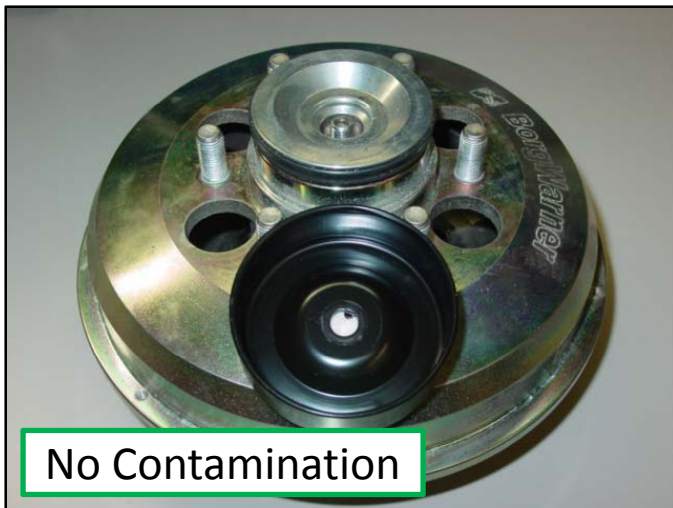
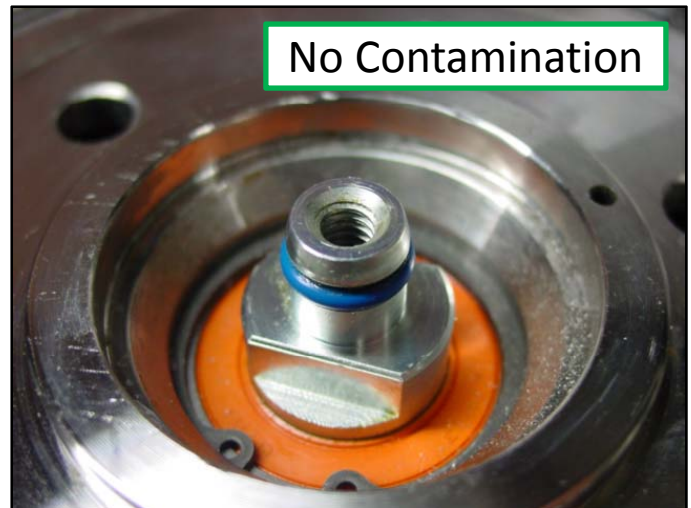
### Air System Contamination

Disassembly of the clutch is not required - images are provided for reference only. Contamination in the air system may cause air seal leaks, operation troubles, or clutch failure. **Any failure due to air system contamination is not warrantable through BorgWarner.**

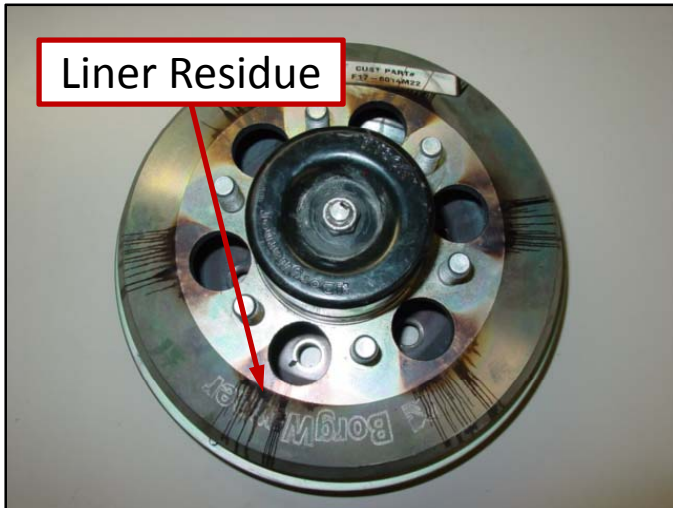
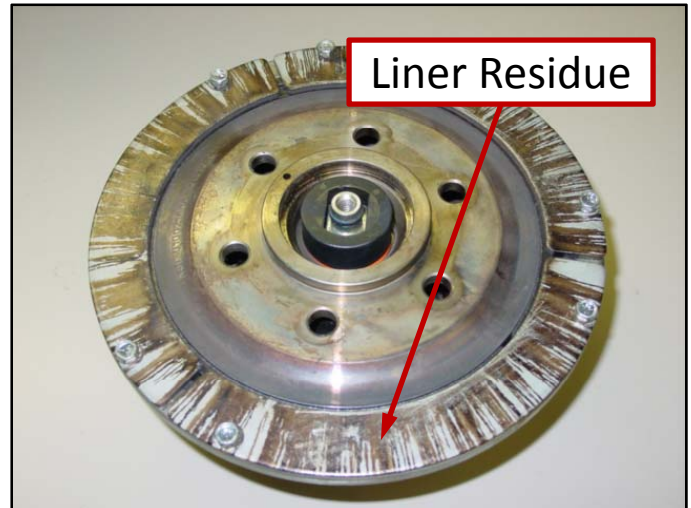
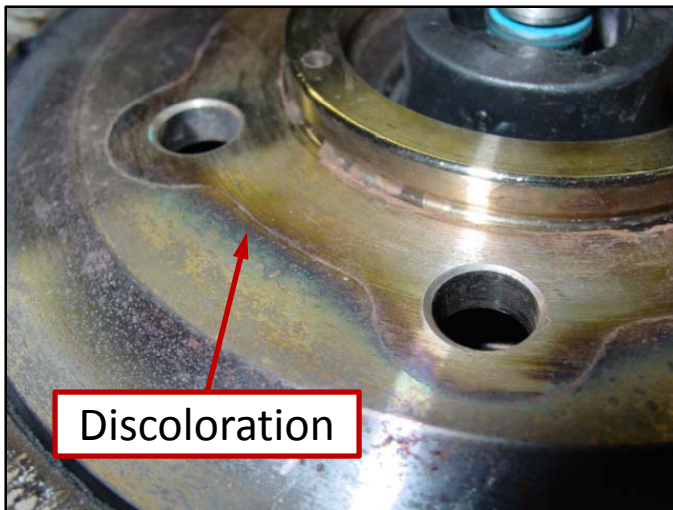
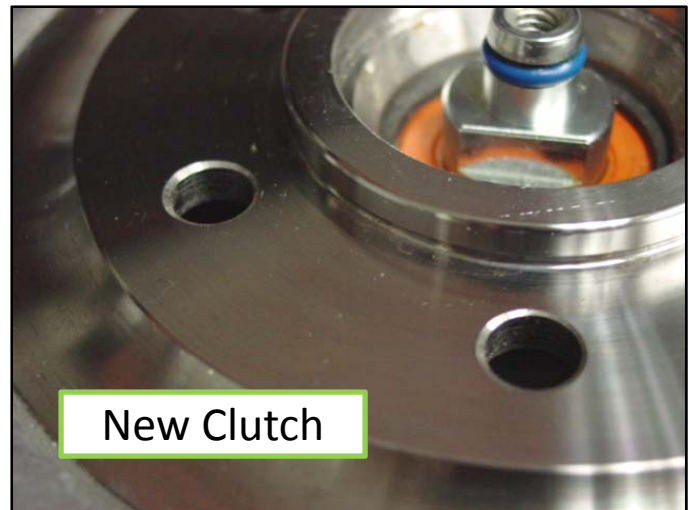
### Control System Issue

A control system issue (potential root causes identified on Pg 19) may cause the clutch to overheat and ultimately fail. Evidence of an overheated clutch includes liner residue on the forward and/or rear face of the clutch, discoloration of the rear face of the clutch, an extremely worn liner, or even a melted coupler. **Any failure due to a control system issue is not warrantable through BorgWarner – check with the OEM for possible warranty coverage.**

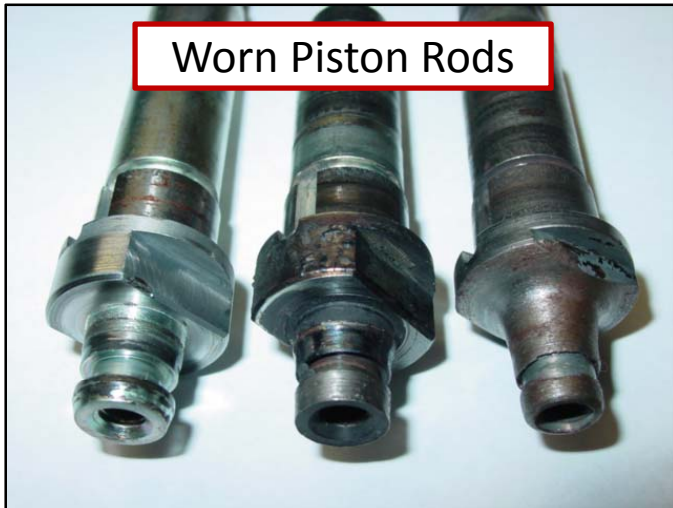
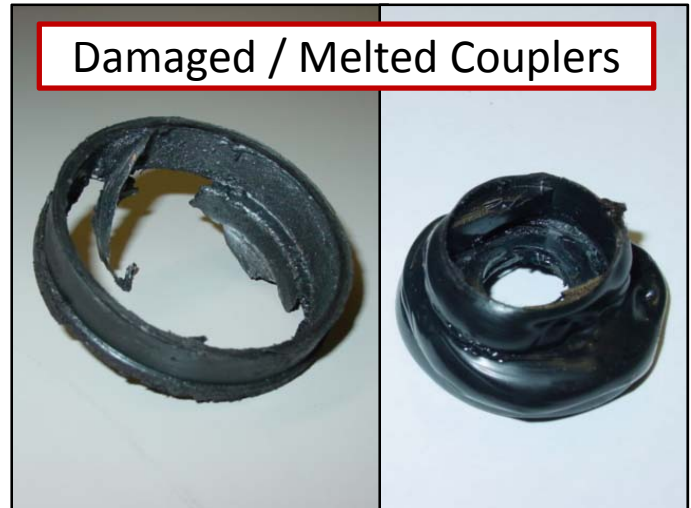
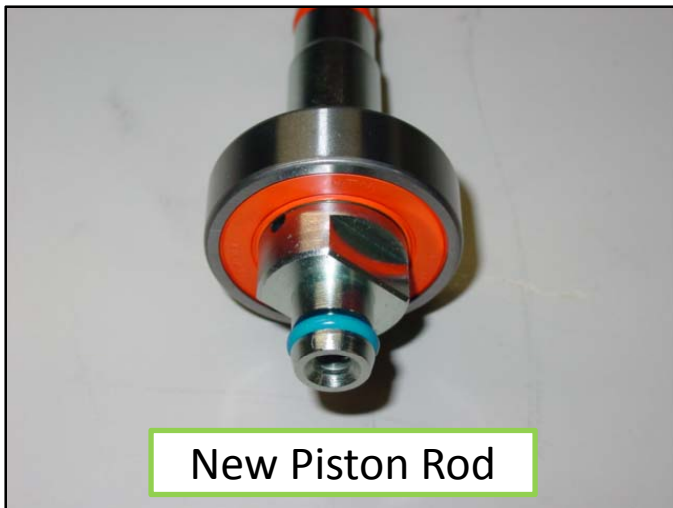
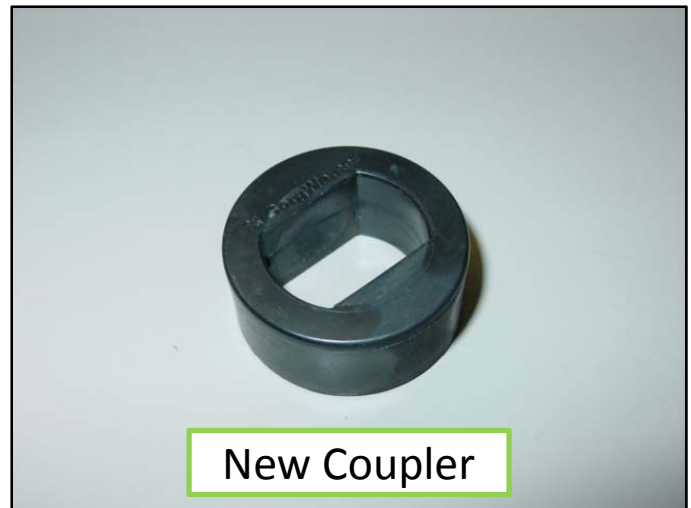
## Evidence of Pulley Bearing Failure

Damage to the base of the piston rod or o-ring may be caused by a pulley bearing failure. A rounded-out or melted coupler may also be caused by a pulley bearing failure. Inspect for play or rough motion in the pulley bearings (See Pg 9). **If a clutch is damaged by a hub failure, and the hub is still under warranty, then both the clutch and hub must be returned to BorgWarner for warranty consideration.**

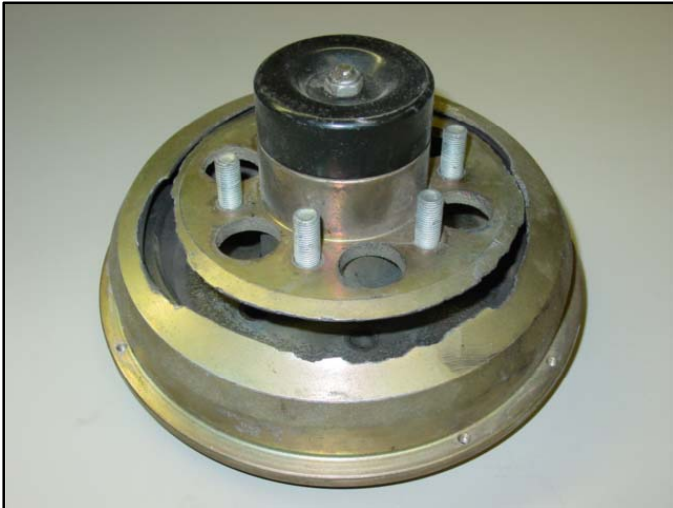
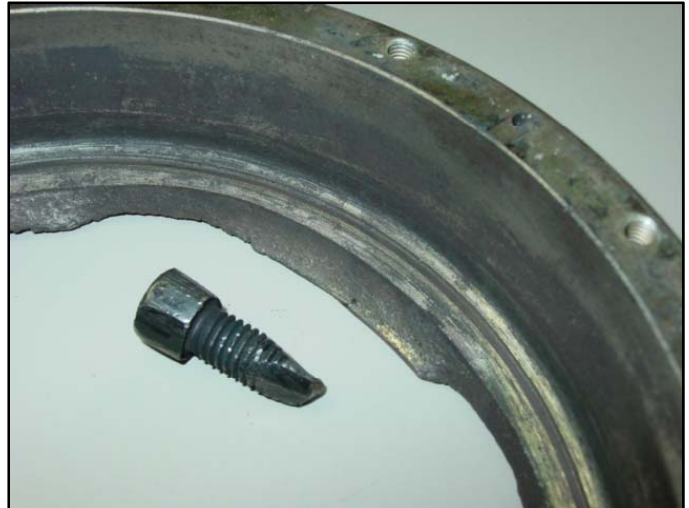
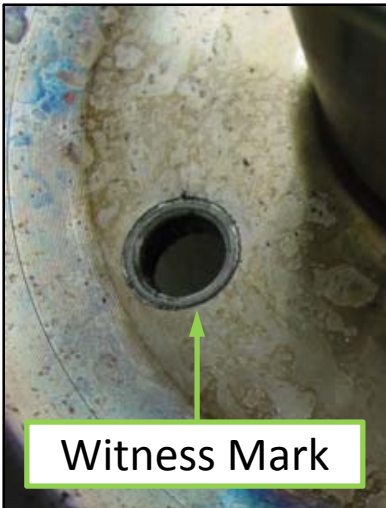
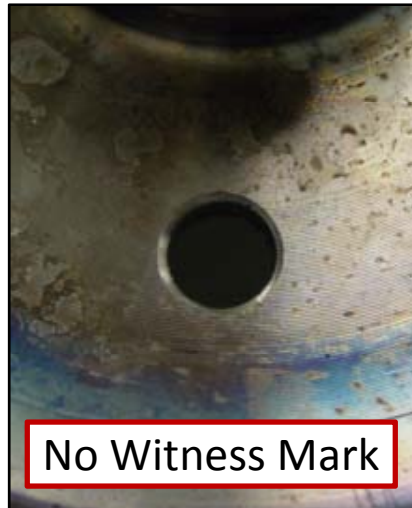
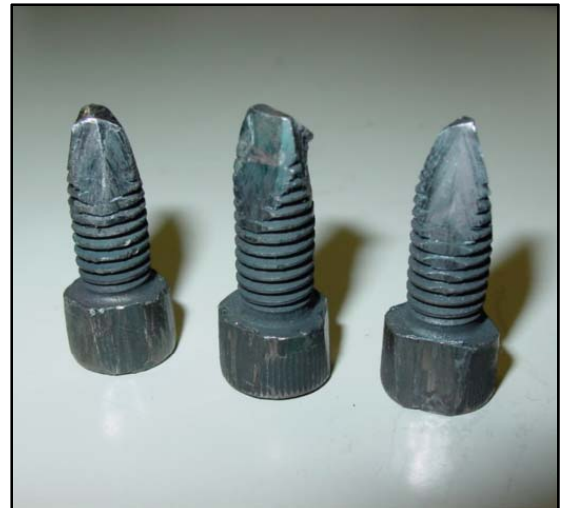
## Improper Installation

Any extra bolts left loose inside the clutch housing will cause internal damage during clutch operation. Any of the 6 clutch mounting bolts that are not torqued to 45 lbf-ft (61 Nm) may become loose inside the clutch housing and cause internal damage. Bolts that are properly torqued will leave a witness mark in the clutch shaft. **A failure due to improper installation is not warrantable through BorgWarner, unless the failure occurred on an original equipment factory installation.**

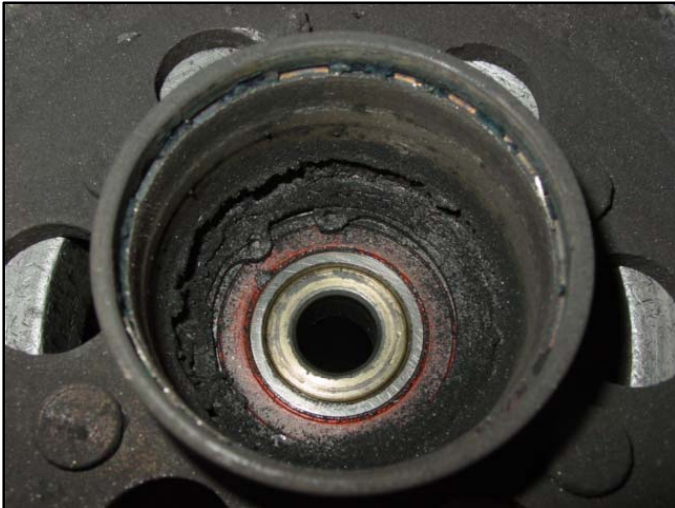
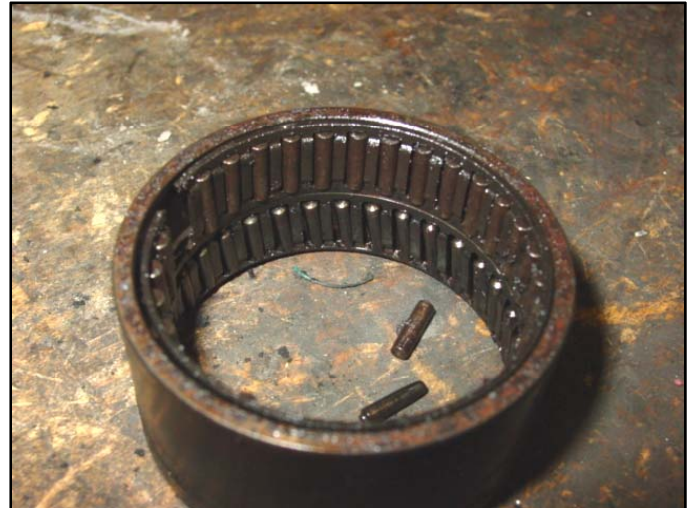
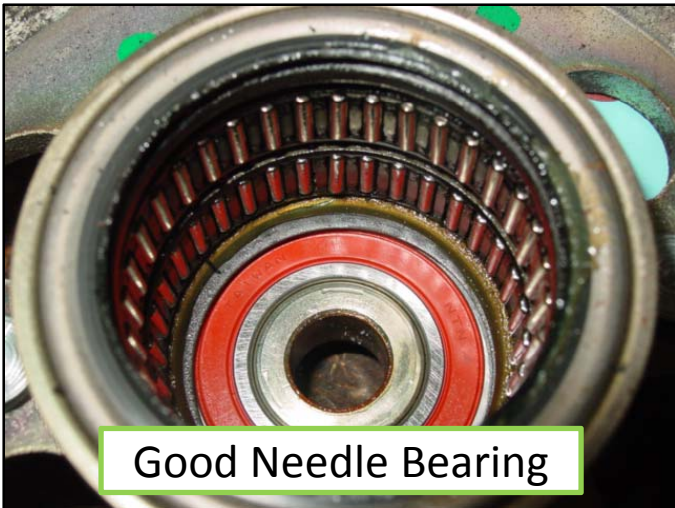
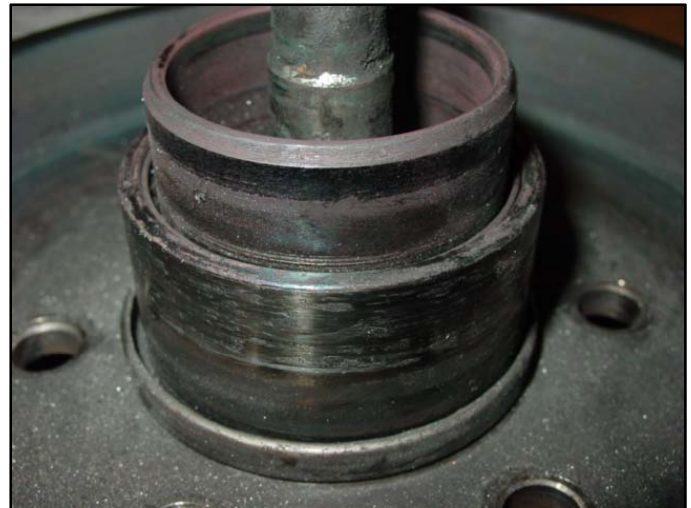
## Needle Bearing Failure

Disassembly of the clutch is not required - images are provided for reference only. Needle bearing failures are rare, but can occur. **If a needle bearing fails due to a hub failure (see Pg 20), and the hub is still under warranty, then both the clutch and hub must be returned for warranty consideration.** If a needle bearing fails without a hub failure, then the clutch alone may be returned for warranty consideration. A needle bearing failure due to a defect in material or workmanship is warrantable through BorgWarner.

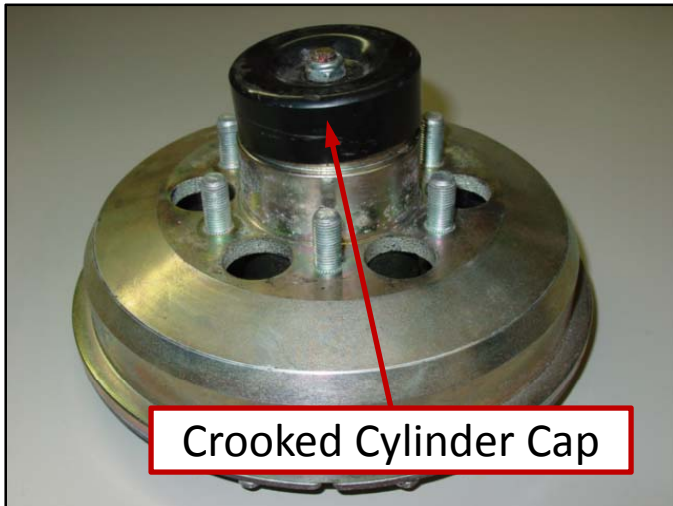
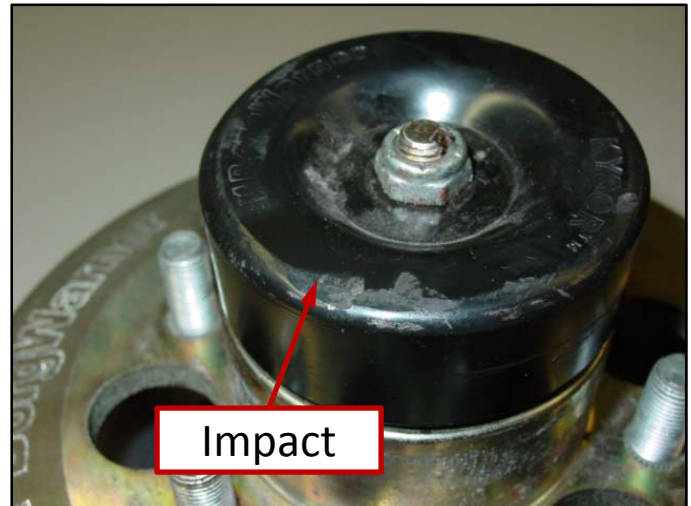
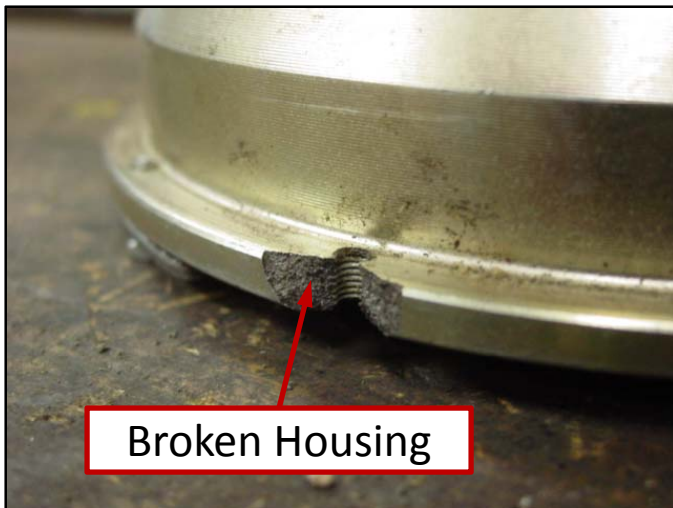
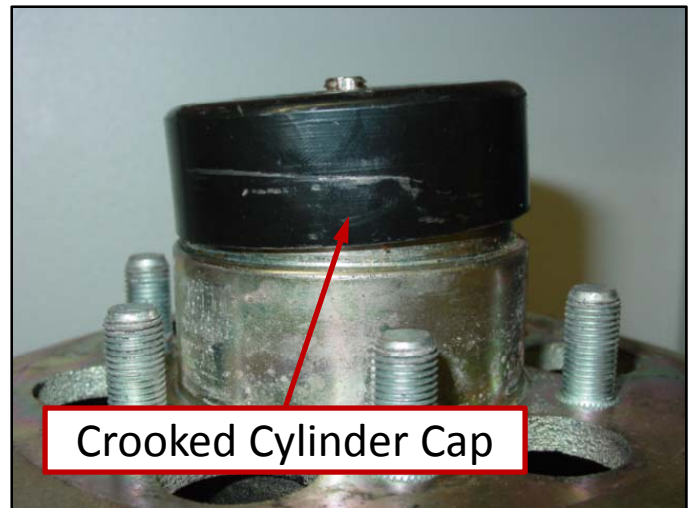
## Physical Damage

An impact to the cylinder cap may bend the piston rod (which carries the cylinder cap) and produce an air seal leak. The bent piston rod may even prevent the clutch from engaging or disengaging. An impact to the clutch housing, especially near a fastener hole, may fracture the housing and cause a fastener to become loose or lost. **A failure due to physical damage of any kind is not warrantable through BorgWarner.**
