Review

# Applications of infrared thermography for the investigation of historic structures

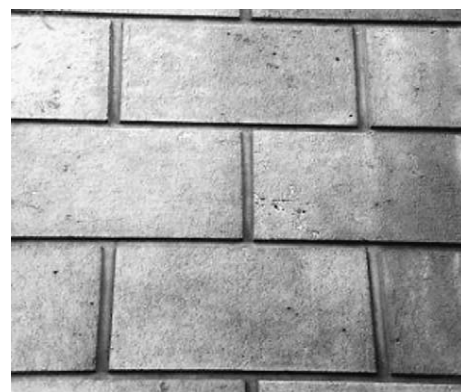
Fig. 2. Kapandriti's stone surface at the Bank of Greece historic building in Athens.

exclusively of calcite grains and quarried from mountain Penteli in Athens, is shown; whilst in Fig. 2 the investigated porous stone surface (Kapandriti's stone), consisting mainly of calcite minerals and quarried from the Kapandriti area in Attica, is presented [15].

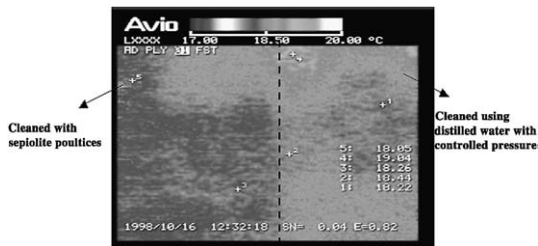
Fig. 4. Thermal image of Kapandriti's stone surface.

From the obtained thermal images, it can be observed that the architectural surfaces, either of marble or of porous stone, where cleaning was applied with the use of sepiolite poultices, on the left part of thermal images from Figs. 3 and 4, there are traces of moisture deposits (indicated with low temperatures on the thermal images) when compared to the right part of the thermal images, where cleaning was accomplished using distilled water with controlled pressure. Since the specific heat of water is approximately five times greater than marble or porous stone, this would mean that any changes in temperature would be much slower in an area contaminated by water. So, the affected by water areas present lower temperatures and thus can be detected by thermography.

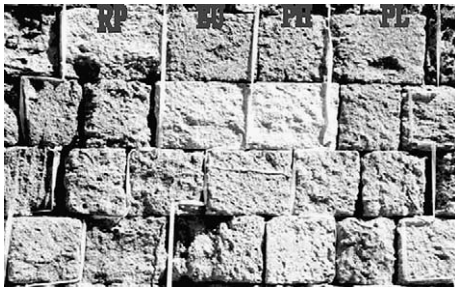
Fig. 6. Consolidated masonry under investigation in the Medieval City of Rhodes (south orientated).

In Figs. 5 and 6, photographs of masonry within the Medieval City of Rhodes in Greece, comprised of large consolidated stone blocks, are presented. The masonry is orientated southeast and south, respectively. The consolidation interventions on both masonries were performed in 1997. The consolidation materials used were silicon-based materials since they present good compatibility with the stone, chemical stability owing to the Si–O–Si bond, preventing discoloration. Furthermore, due to the low viscosity of these products they provide deep penetration into the stone. The capillary system of the stone in combination with the low viscosity of the solutions used, facilitated the application of spraying; the products are presented in Table 2.

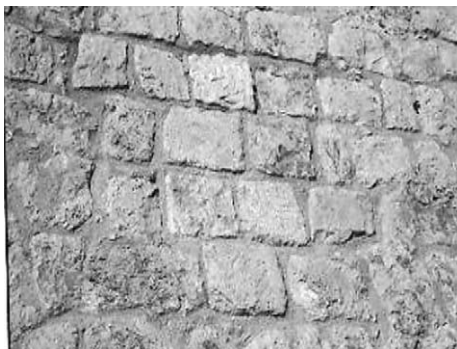
Fig. 9. Fortification masonry facing the National Stadium of Heraklion in Crete.

So, in this work, a thermographic survey on the fortification masonry facing the National Stadium of Heraklion in Crete, as well as the western façade of one of the recent industrial monuments, the Tobacco Cutting Factory, situated in the centre of the historic Heraklion market nearby the seaboard provided evidence that cement mortars generate reinforced damage to the original materials of the historic structures. The two examined masonries are presented in Figs. 9 and 10.

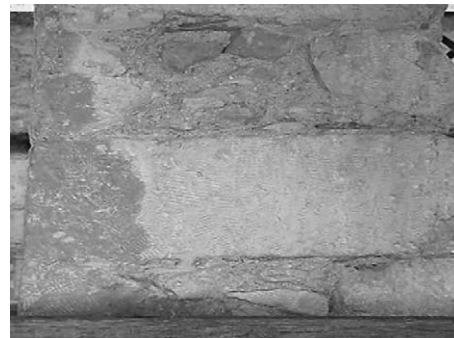
Fig. 10. Western facade of the Tobacco Cutting Factory in Heraklion, Crete.

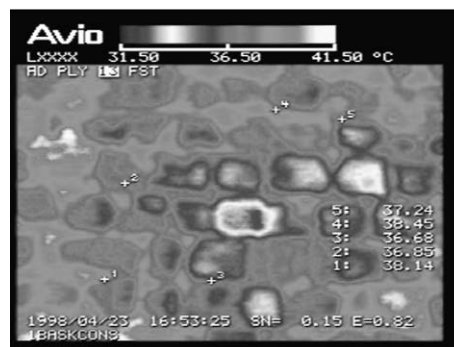
Fig. 11. Thermal image of masonry in the National Stadium of Heraklion.

The obtained thermal images presented in Figs. 11 and 12 show a different behaviour of the joint mortar; cold building stones and hot joint mortars. This is because the old ones attain nearer temperatures to the stones, whilst cement mor-

tars attain much higher temperatures, due to their impermeability to salt solutions [22].

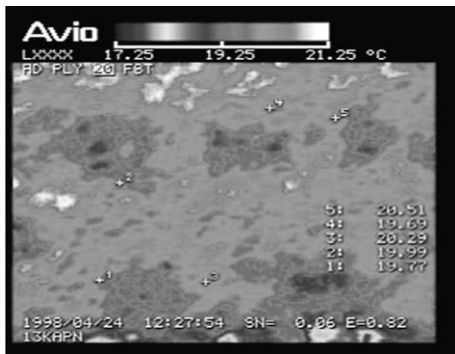
Fig. 12. Thermal image of western facade from the Tobacco Cutting Factory.
