# 3 PRESERVATION BRIEFS

## Improving Energy Efficiency in Historic Buildings

National Park Service  
U.S. Department of the Interior

Technical Preservation Services

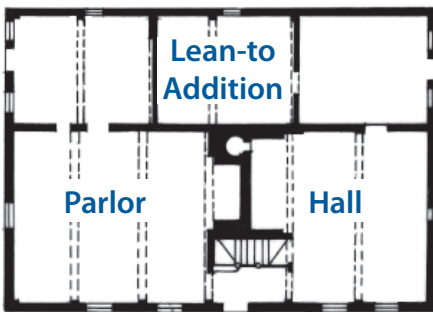
*Fig. 4. A typical New England saltbox features a steeply sloping roof to shed snow and a floor plan organized around a central chimney to conserve heat.*

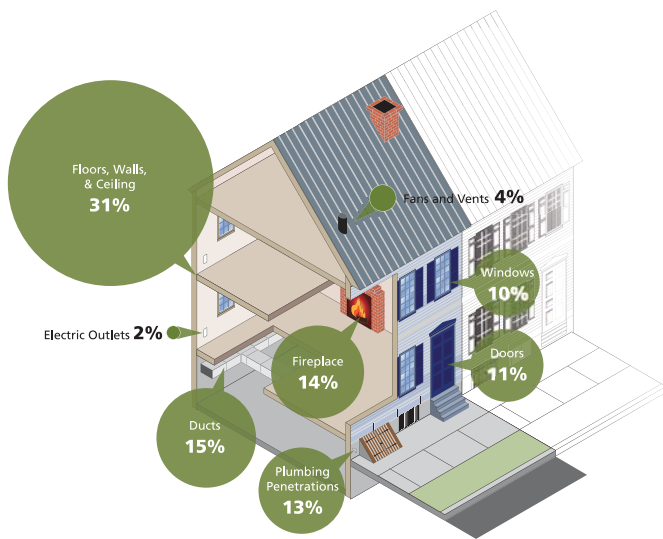
Fig. 8. Where Air Escapes From a House (by percentage) – Image based on data from Energy Savers, U.S. Department of Energy. Illustration: Blank Space LLC.

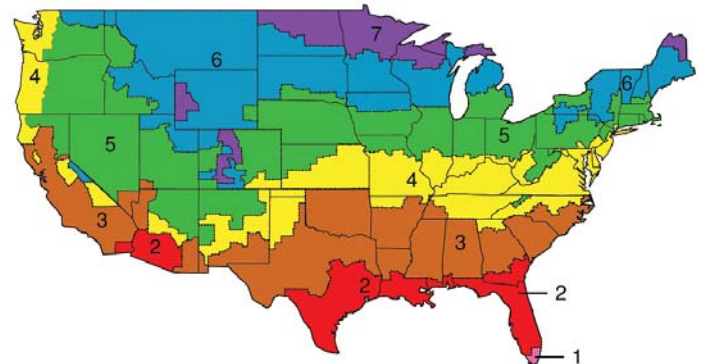
Fig. 12. Recommended energy improvements vary widely based on climate. The information contained in this document is based primarily on the available data for the Northeast and Mid-Atlantic regions.

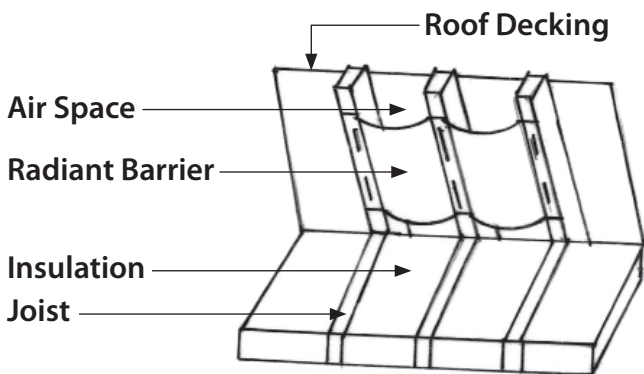
Fig. 13. Sample installation of a radiant barrier.

Radiant barriers may be used in attics to reduce thermal radiation across the air space between the roof deck and the attic floor in order to reduce summer heat gain. They are most beneficial in reducing cooling loads in hot climates and consist of a highly reflective sheet or coating, usually aluminum, applied to one or both sides of a flexible material. They are effective only when the foil surface faces an air space, and as long as the surface remains shiny – that is, free from dirt, dust, condensation and oxidation. Radiant barriers should not be installed directly over insulation on the attic floor, as they can act as vapor retarders and trap moisture in the insulation unless they are perforated. Their placement should be ventilated on both sides.

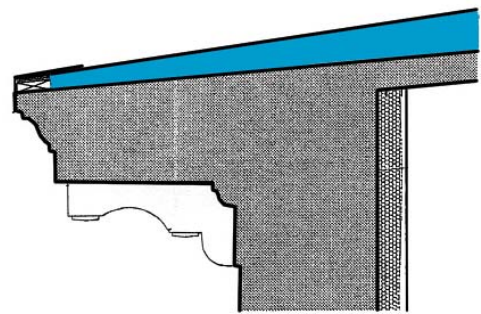
Fig. 14. Sample installation of rigid foam insulation, tapered at the edge to avoid altering the appearance of the roof.

When total roof replacement is required because of deterioration, installing rigid foam insulation on top of the roof deck before laying the new roofing material

can be simple and effective, particularly on low-pitched or flat roofs. However, the added thickness of the roof caused by installing rigid foam can alter the appearance of projecting eaves, dormers, and other features. If this application would significantly alter the appearance of these features, consider other methods.

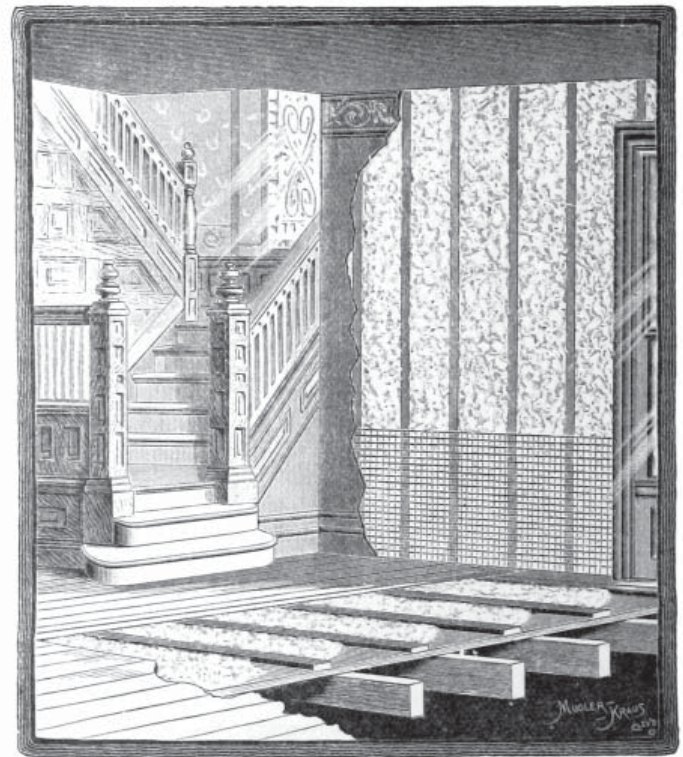
AN INTERIOR

Showing Mineral Wool in Floor, and Walls behind Wire Lath.

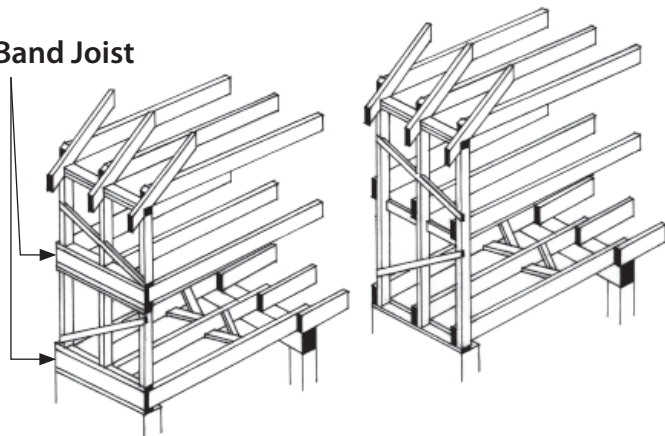
Fig. 19. Platform framing (left) and Balloon framing (right).

the insulation in the adjacent wall cavities. In balloon-framed buildings, the wall cavity is continuous between floors except where fire stops have been inserted.

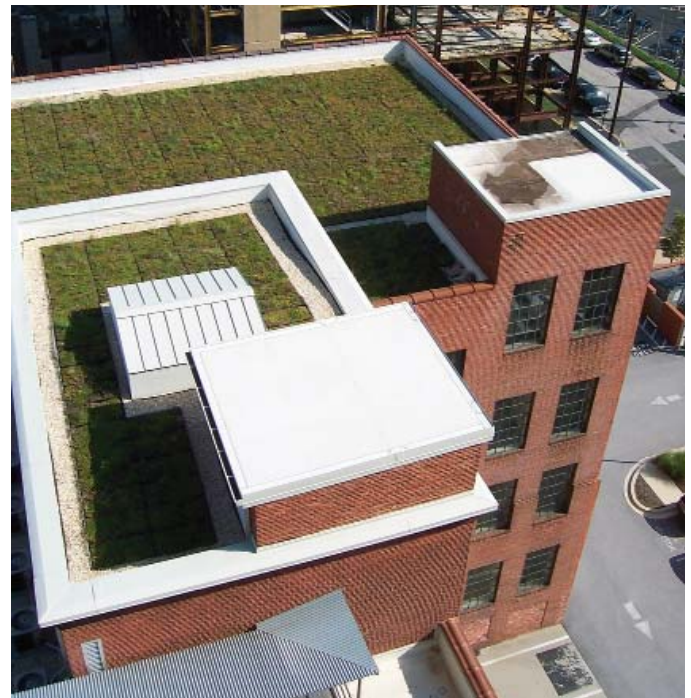
*Fig. 22. Installation of both cool and green roofs in an urban environment.*

light-colored or white roofs, and fiberglass shingles that have a coating of reflective crystals. All of these roofing materials reflect the sun’s radiation away from the building, which lessens heat gain, resulting in a reduction of the cooling load. Cool roofs are generally not practical in northern climates where buildings benefit from the added heat gain of a dark-colored roof during colder months. Cool and green roofs are appropriate for use on historic buildings only when they are compatible with their architectural character, such as flat roofs with no visibility. A white-colored roof that is readily visible is not appropriate for historic metal roofs that were traditionally painted a dark color, such as green or iron oxide red. A white reflective roof is most suitable on flat roofed historic buildings. If a historic building has a slate roof, for example, removing the slate to install a metal roof is not a compatible treatment. It is never appropriate to remove a historic roof if the material is in good or repairable condition to install a cool roof. However, if the roof has previously been changed to an asphalt shingle roof, fiberglass shingles with special reflective granules may be an appropriate replacement.

A green roof consists of a thin layer of vegetation planted over a waterproofing system or in trays installed on top of an existing flat or slightly sloped roof. Green roofs are primarily beneficial in urban contexts to reduce the heat island effect in cities and to control storm water run-off. A green roof also reduces the cooling load of the building and helps cool the surrounding urban environment, filters air, collects and filters storm water, and can provide urban amenities, including vegetable gardens, for building occupants. The impact of increased
