## On/Off Fan Drive Diagnostic and Warranty Guide

Revision 20120402A

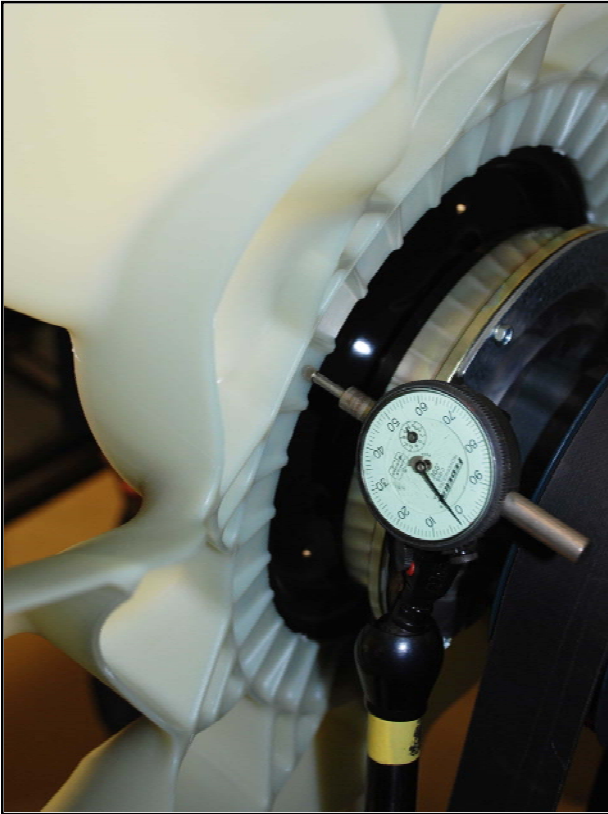
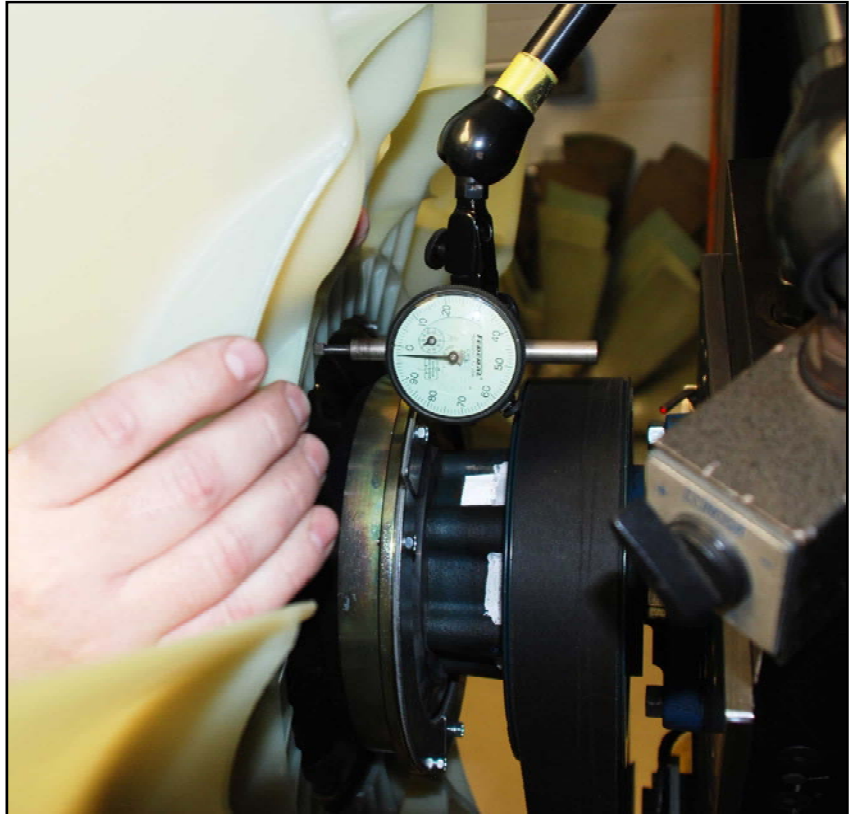
Supply 90-110 PSI air pressure to the fan drive to disengage the clutch. Setup a dial indicator on a flat rear surface of the fan, very close to the outer rim of the clutch (see the image to the upper left).

Grasp the fan as close to the position of the dial indicator as possible (see the image to the upper right). Gently move the fan forward and rearward (do not force), and record the total indicator reading.

If the total indicator reading exceeds 0.050" (1.27mm) then the clutch should be replaced. If the total indicator reading is less than or equal to 0.050" (1.27mm) then the amount of clutch play is acceptable.

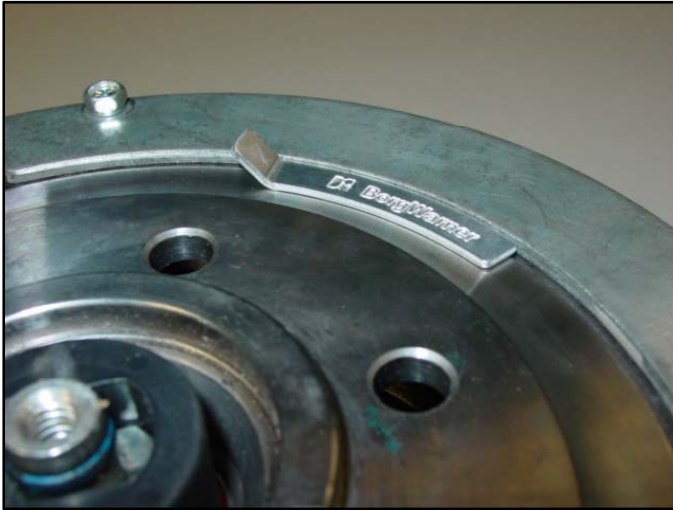
Liner Life Remaining

If the Service Alert Tool sits below the surface of the retainer plate (as shown in the image on the left) then the liner has life remaining. If the Service Alert Tool sits above the surface of the retainer plate (as shown in the image on the right) then the liner should be replaced as soon as possible. See Pg 18 to determine whether a control system issue is responsible for rapid liner wear.

*Note: the Service Alert Tool has a thickness of 0.062" – if the Service Alert Tool is not available, then the liner should be replaced when the clutch shaft's rear face is less than 0.062" forward of the retainer plate's rear face.*
